Manhole Inspection Summary

Manhole # S23Y__013MH

Insp Date: **1/27/09 1:50 PM**

Location Address: **2201 Langley St.**

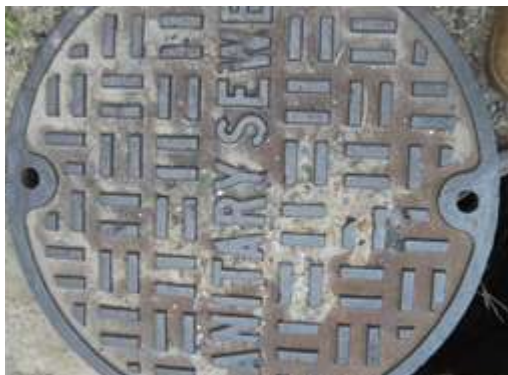
Misc

cover

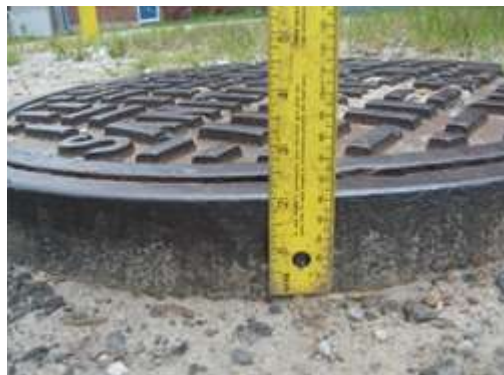
Misc

cover 2 inches above grade in off-road area

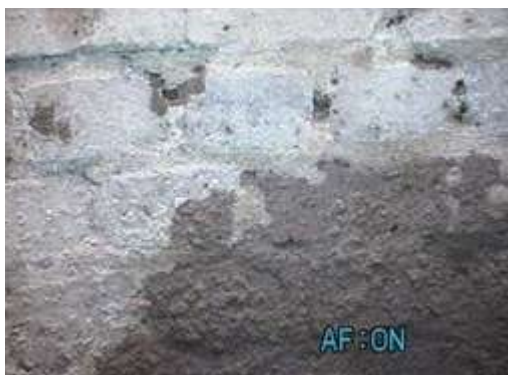
Defect 1

Infiltration: ☐ None ☐ Joint ☐ Cracks ☐ Mortar ☐ Roots ☒ **Wall**

barrel infiltration at wall

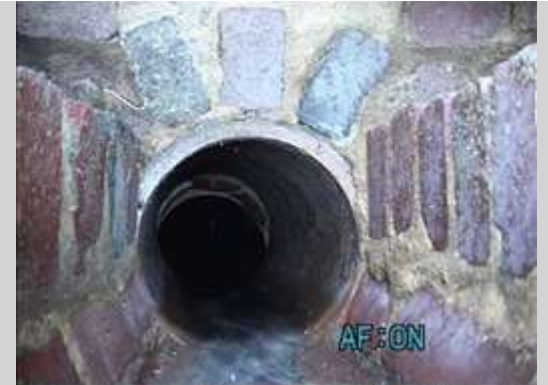
12 O'Clock Outflow

8 in. Circular Gravity Sewer
Pipe Out @ 12 O'Clock

Pipe Height: **8.4** (in.) Rod and Bar (Angled)
Pipe Material: **Clay** ☐ Pipe Lined
Invert Depth: **7.92** (ft.) Flow Characteristics: **Slow**
Deposits: ☒ None ☐ Mud ☐ Sludge ☐ Debris ☐ Grease
Silt Depth: **0** (in.) Deposits Extent:
Infiltration: **None** Pipe Seal Cond: **Sound**

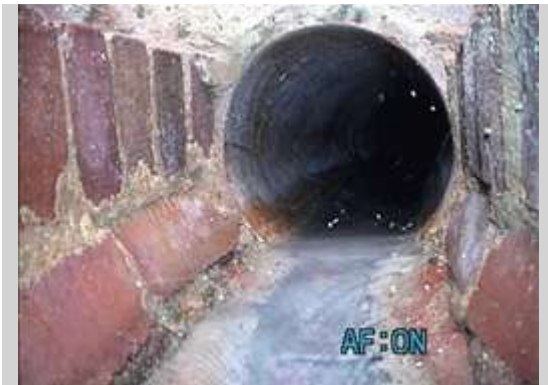
7 O'Clock Inflow

8 in. Circular Gravity Sewer
Pipe In @ 7 O'Clock

Pipe Height: **8.4** (in.) Rod and Bar (Angled)
Pipe Material: **Clay** ☐ Pipe Lined
Invert Depth: **7.85** (ft.) Flow Characteristics: **Slow**
Deposits: ☒ None ☐ Mud ☐ Sludge ☐ Debris ☐ Grease
Silt Depth: **0** (in.) Deposits Extent:
Infiltration: **None** Pipe Seal Cond: **Sound**
